# *Linkhorn Inspection Group LLC*

## Confidential Property Inspection Report

1234 N Main St, Dublin, OH 43016  
Inspection prepared for: John Doe  
Date of Inspection: 1/29/2019 Time: 1:30 PM  
Age of Home: 2005 Size: 1924  
Weather: Snowing 15 degrees

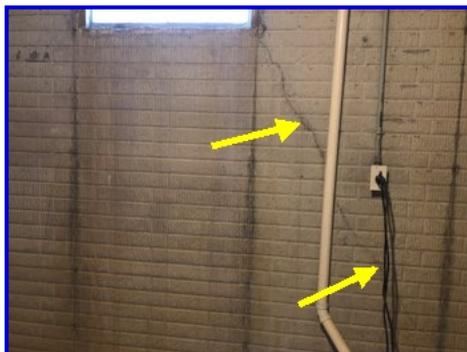
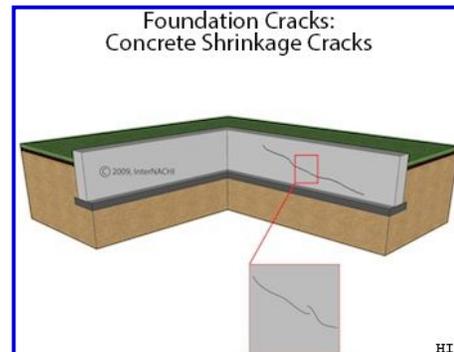
Monitor: Minor vertical cracks were observed in the foundation. This type and pattern of cracking is usually the result of concrete shrinkage as it cures. Shrinkage cracks are not normally a concern. These cracks may need sealing on the exterior to prevent moisture penetration.

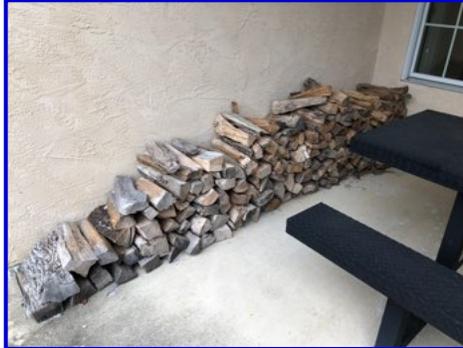
Improve: Firewood storage should be moved away from the house. Wood storage against the house increases risk of wood destroying insect activity.

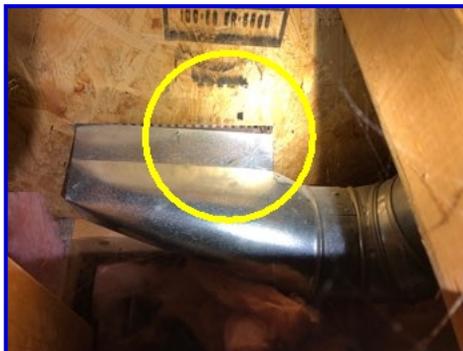
• **Repair:** Disconnected ductwork in the crawl space should be repaired (west crawspace). Disconnected duct work increases heating/cooling costs.

Disconnected vent in (west) crawspace

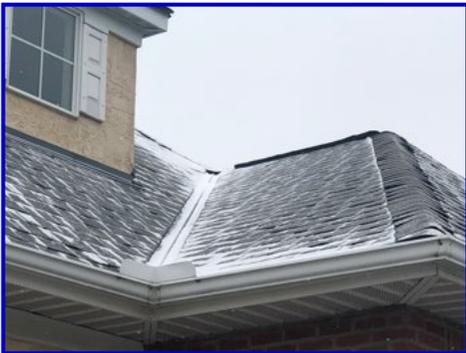
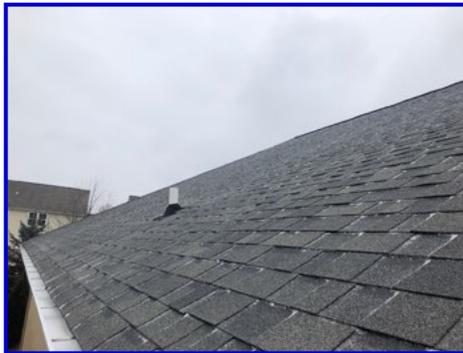
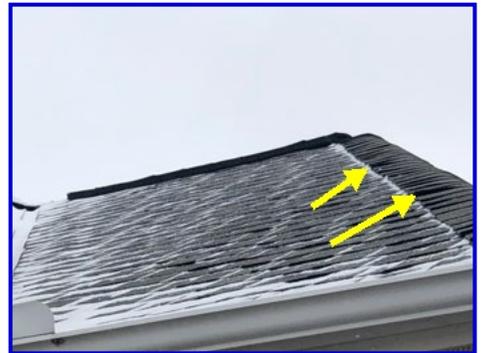
- **Possible Repair:** Minor repairs to the roofing may be needed to prevent wind damage. Loose or curling cap shingles should be secured or repaired. All roof penetrations should be examined and sealed as necessary. Aging or loose flashing can cause leaks, these items should be maintained periodically to prevent water intrusion.

Loose or curling cap shingle should be secured or repaired

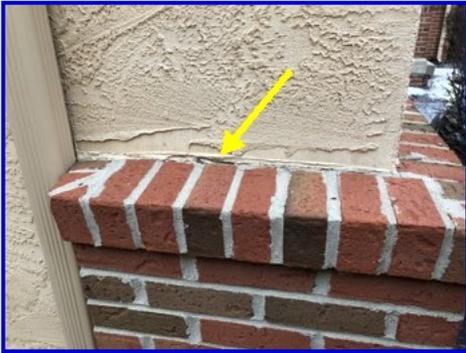
• **Improve:** The siding is lacking proper sealant joints at intersections of dissimilar materials. This condition should be repaired to help prevent moisture intrusion. (Brick meets wood, stucco meets wood or brick, window or trim intersections, etc.)

Seal joints of dissimilar materials (Southeast corner)

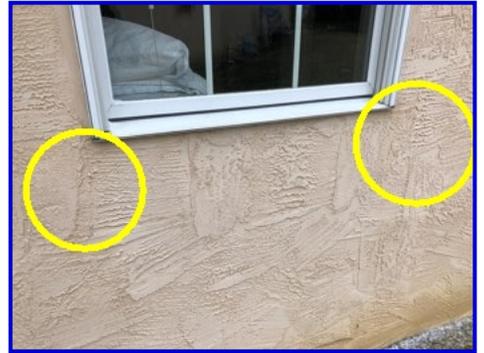
• **Repair:** Localized damage of the stucco exterior walls (staining and or cracks) should be repaired at (around exterior windows). There is extra risk of hidden damage in such areas caused by previous or present leaks that should be repaired. It is recommended that a qualified stucco contractor be consulted to further evaluate the stucco system to determine if additional hidden damage may be present. Unfortunately, stucco/stone exteriors are very vulnerable to moisture intrusion, and can cause damage that is not visible in the course of a home inspection.

Stucco cracks should be repaired (around exterior windows)

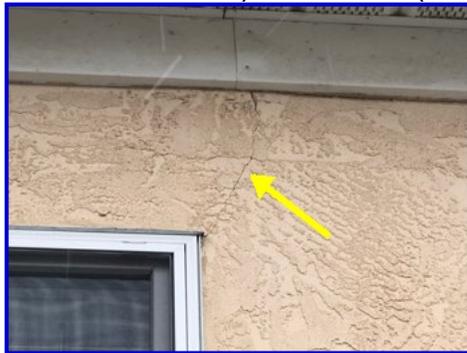
Stucco cracks should be repaired (around exterior windows)

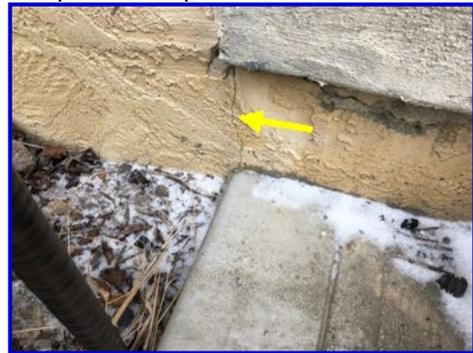
Stucco crack observed (rear of home above patio)

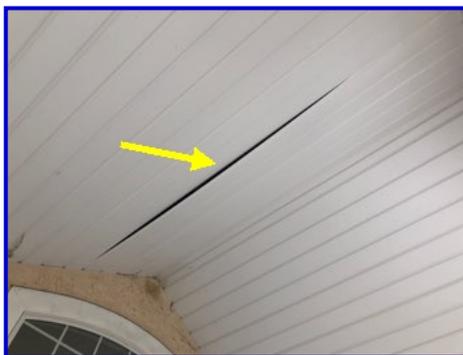
- **Repair/Replace:** Loose soffit should be repaired at (rear covered porch).

Loose soffit (rear covered porch)

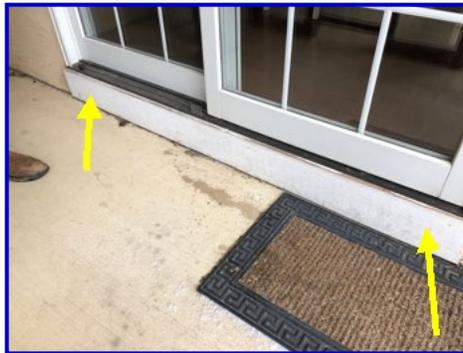
Improve: Exterior door trim is lacking paint maintenance and should be improved.

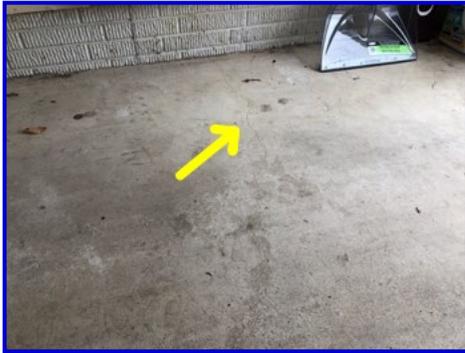
• **Monitor:** The garage floor slab has typical cracks usually the result of shrinkage and/or settling of the slab. Cracks more than 1/8" high could present a trip hazard.

Garage has typical floor cracks

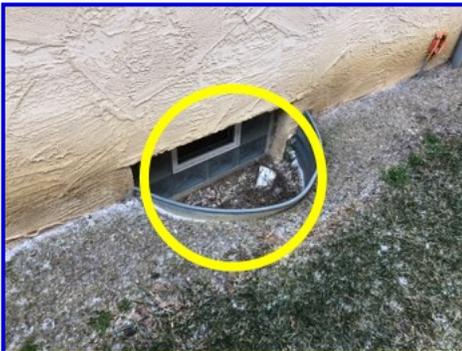
Recommend installing covers for window wells

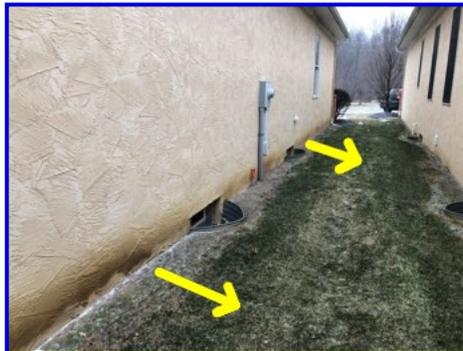
- **Improve:** The grading should be improved to promote the flow of storm water away from the house. This can often be accomplished by the addition or re-grading of top soil. The ground should slope away from the house at a rate of one inch per foot for at least the first ten feet. At least eight (8) inches of clearance should be maintained between soil level and the bottom of exterior wall siding.
- **Improve:** Covers should be provided for basement window wells to keep storm water out of the well.

Grading should be improved

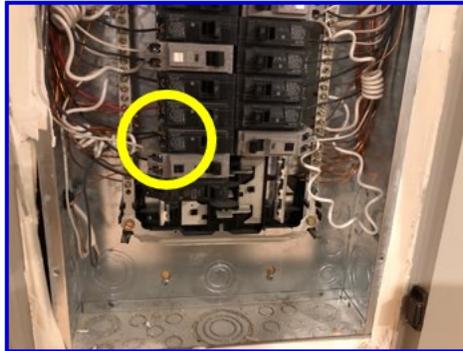
- **Repair:** Circuits within the main panel that are doubled up (referred to as “**double taps**”) should be separated. Each circuit should be served by a separate fuse or breaker. (Left side of panel, 15 amp circuit near bottom)

Repair: Circuits within the main panel that are doubled up (referred to as "double taps") should be separated. Each circuit should be served by a separate fuse or breaker.

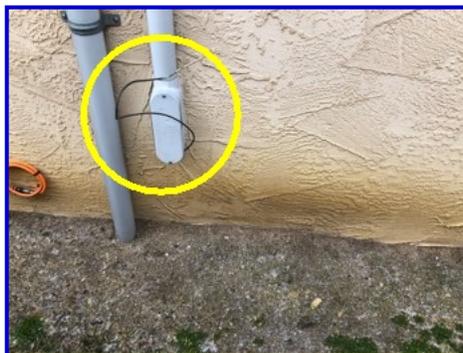
- Repair: Ground wire connection is not connected to ground rod and should be repaired.

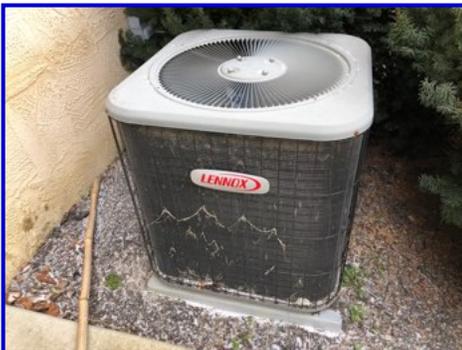
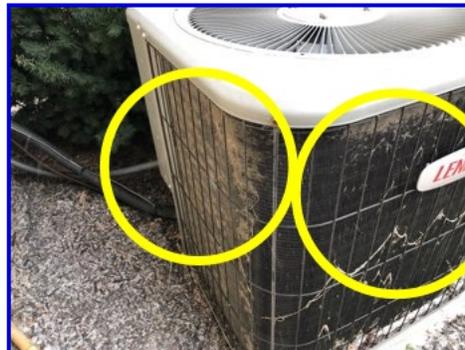
• **Repair: The outdoor unit of the air conditioning system requires cleaning.**

Unit needs cleaned

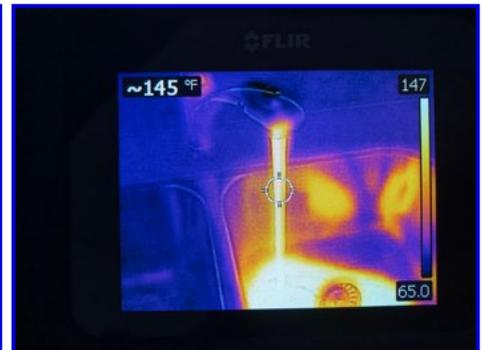
Safety Issue: The hot water temperature was (145) degrees at the time of inspection. This can be a scald hazard. Recommend lowering water temperature for improved safety. Hot water temperatures should not exceed 120 degrees F.

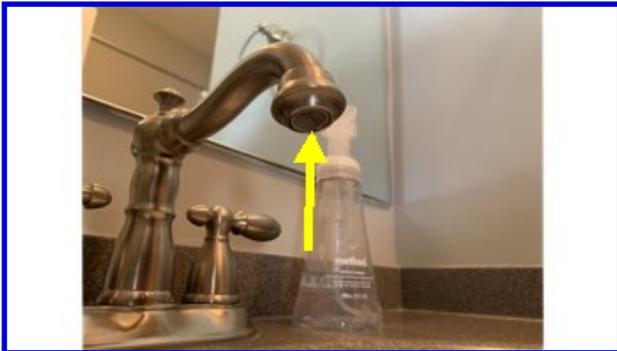
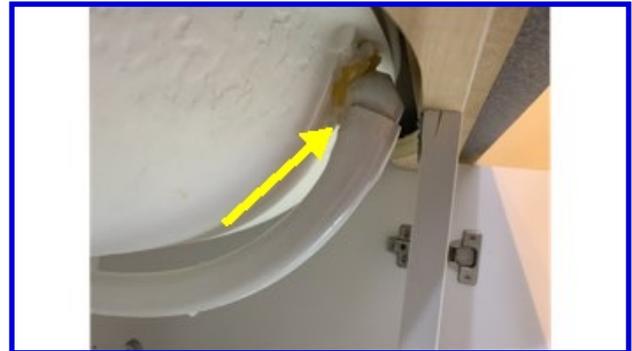
- Repair: Leak under sink at overflow piping should be repaired at (master bath right sink).

Master sink leaks at overflow connection

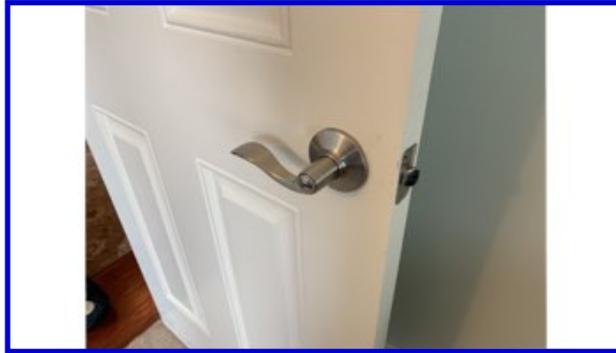
- **Improve:** Doors should be trimmed or adjusted as necessary to work and seal properly. (Front den door doesn't latch)
