# *Linkhorn Inspection Group LLC*

## Confidential Property Inspection Report

1234 N Main St, Dublin, OH 43016  
Inspection prepared for: John Doe  
Date of Inspection: 1/29/2019 Time: 1:30 PM  
Age of Home: 2005 Size: 1924  
Weather: Snowing 15 degrees

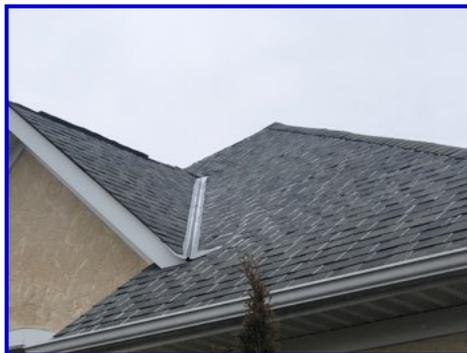
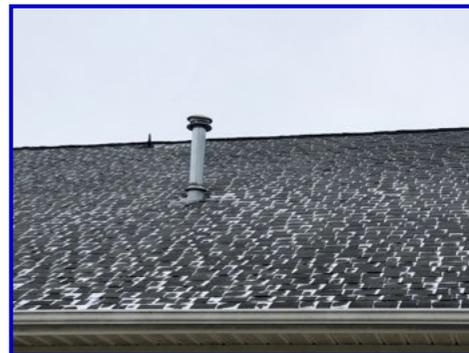
- **Possible Repair:** Minor repairs to the roofing may be needed to prevent wind damage. Loose or curling cap shingles should be secured or repaired. All roof penetrations should be examined and sealed as necessary. Aging or loose flashing can cause leaks, these items should be maintained periodically to prevent water intrusion.

Loose or curling cap shingle should be secured or repaired

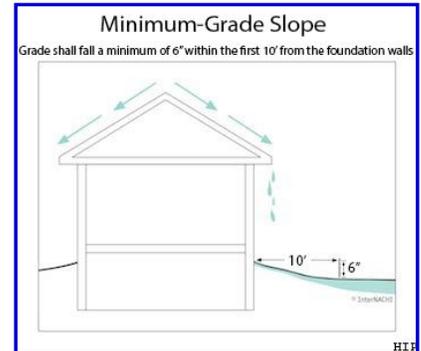
Grading should be improved

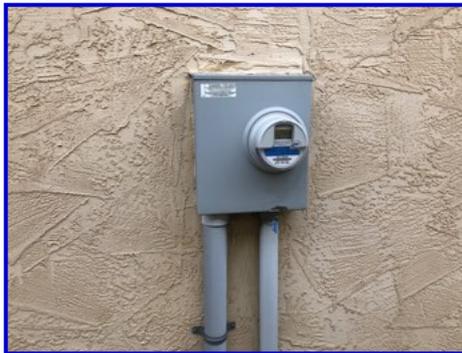
Electric in good condition

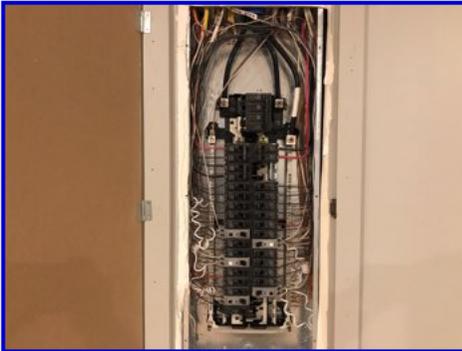
Electrical Panel

- **Repair:** Circuits within the main panel that are doubled up (referred to as “**double taps**”) should be separated. Each circuit should be served by a separate fuse or breaker. (Left side of panel, 15 amp circuit near bottom)

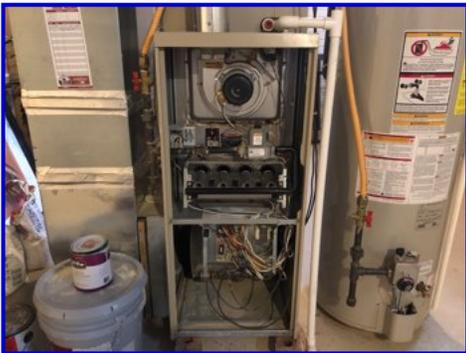
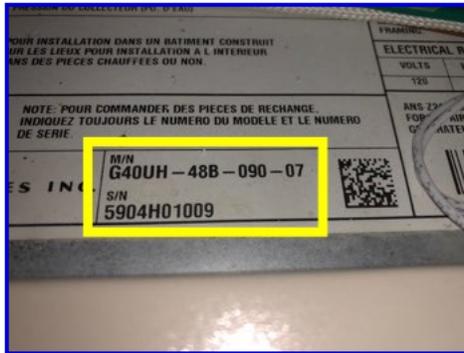
Model and serial number

• **Maintenance Item: The HVAC system should be serviced by a qualified technician yearly. This is recommended by the manufacturer to help prevent breakdowns and help ensure safe operation. (No recent service records/age/condition)**

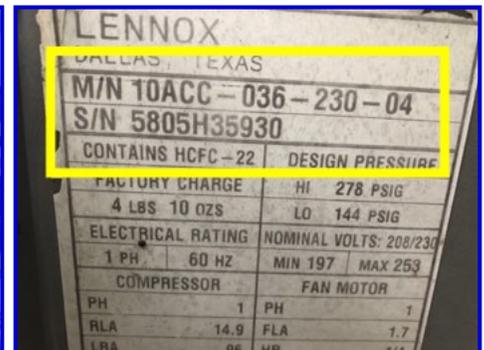
Model and serial number

Cooling system		
Page 18	Cooling system observation	• Repair: The outdoor unit of the air conditioning system requires cleaning.
Plumbing

Unit needs cleaned

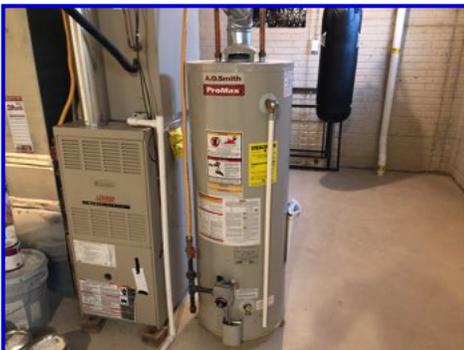
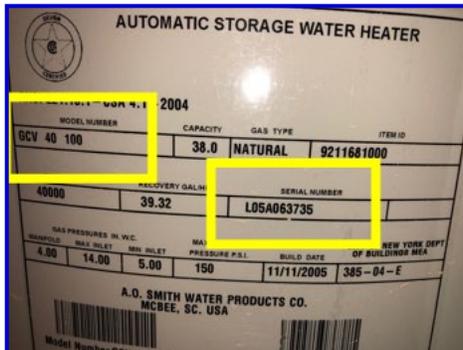
Model and serial number

- Model number and serial number
- Water heater was working and no visible evidence of leaks at time of inspection.
- **Deferred Cost Item:** The water heater is an old unit that may be approaching the end of its useful life. It would be wise to budget for a new unit. One cannot predict with certainty when replacement will become necessary.
- **Safety Issue:** The hot water temperature was (145) degrees at the time of inspection. This can be a scald hazard. Recommend lowering water temperature for improved safety. Hot water temperatures should not exceed 120 degrees F.

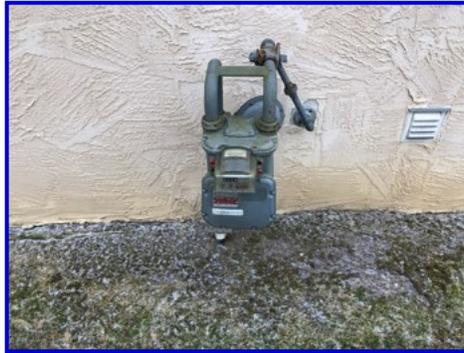
Main gas meter (north wall)

- **Repair:** The yellow flexible steel gas line should be grounded to electric panel or replaced with black lightning rated **CSSI** (corrugated stainless steel tubing). This will help prevent mechanical failure if house is struck by lightning.

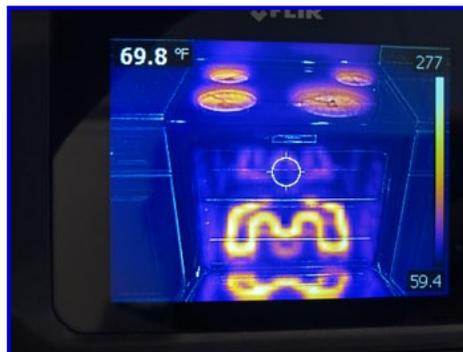
All burners and oven heating element were operational at time of inspection.

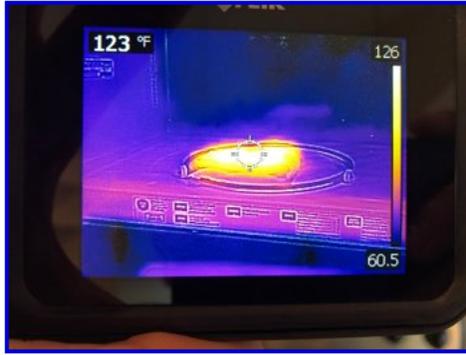
The microwave functioned when tested at the time of inspection.
